COUNTRY East Germany Approved For Release 2002/07/12 : CIA-RDP80-00810A000600270004-2

TOPIC Stendal-Borstel Airfield

DATE OF CONTENT 20 December 1952 to 21 January 1953

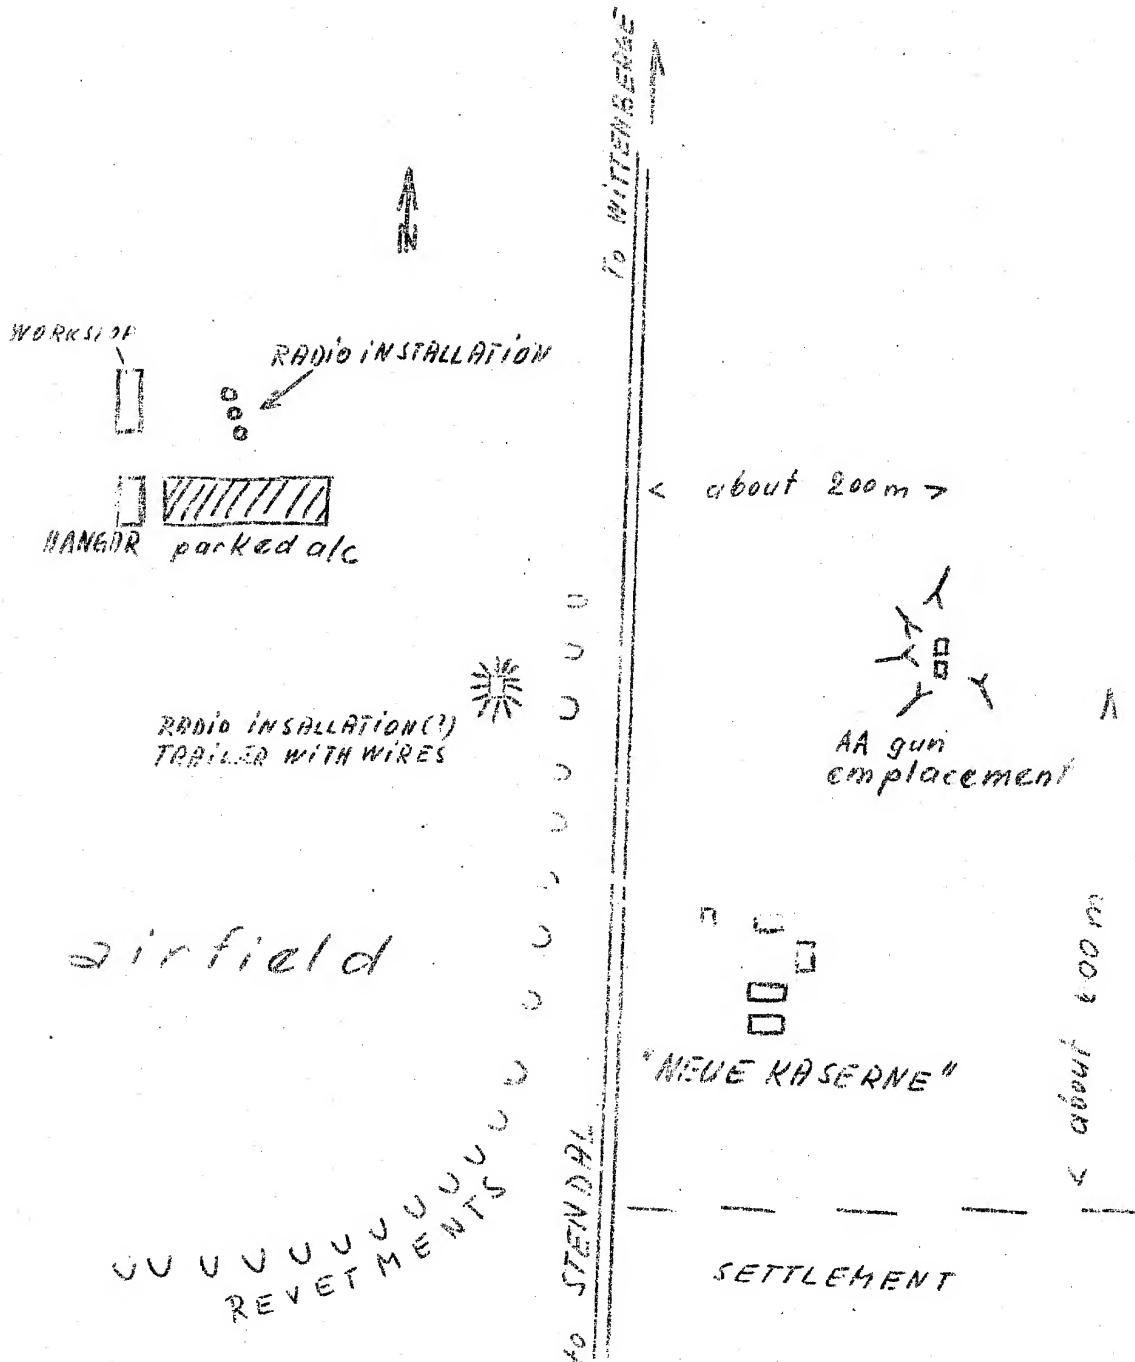
Location Sketch of Radio Installation at Stendal-Borstel Airfield

2. On 20 December, three radio masts were observed about 150 meters east of the repair hangar at the field. Two of them were 10 to 15 meters high and interconnected by an antenna, the third one was about 18 meters high with a cage antenna, about 1 meter in width, and a number of rods, about 1 meter long, on top.²

Comment. For location of radio installation, see Annex 1.
3.

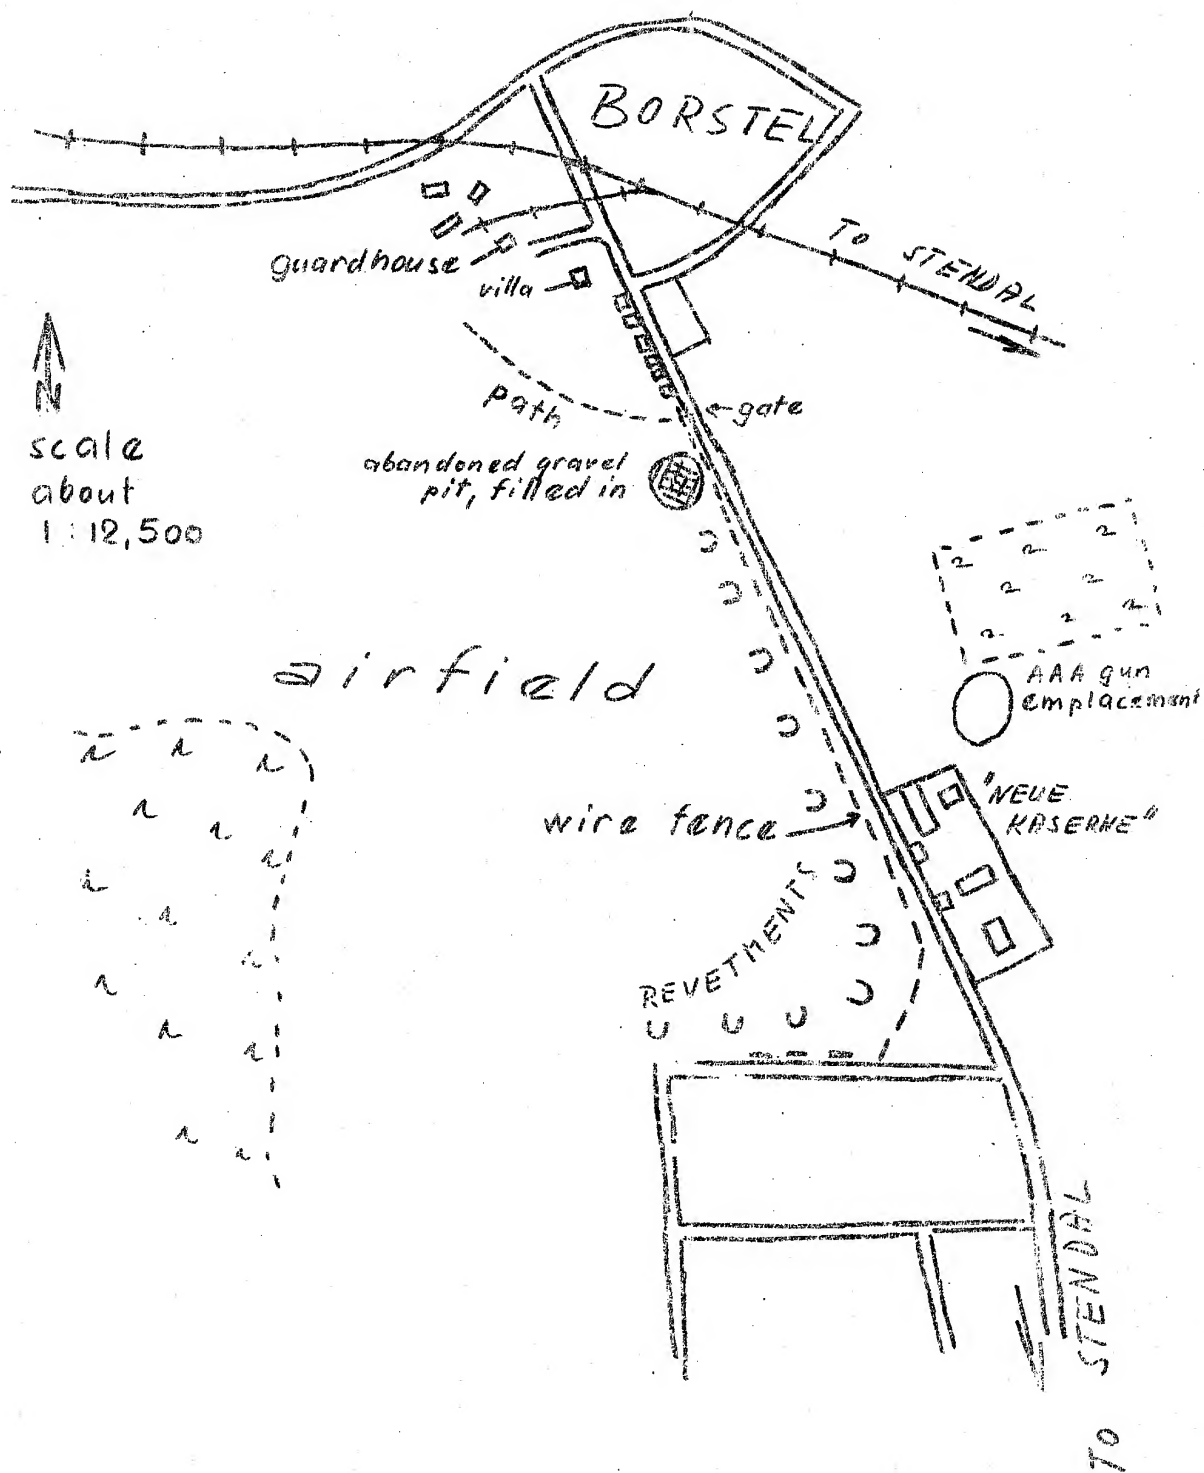
Stendal-Borstel Airfield

3. On 20 December, about 40 shrapnelproof aircraft revetments with wooden inner walls and earth-covered outer walls were observed around the field. Each revetment consisted of three walls with two openings at the rear.

Comment. For location of shrapnelproof aircraft revetments, see Annex 2.
